# EAST SPRINGFIELD BRANCH LIBRARY

21 Osborn Terrace  
Springfield, MA 01104

## FACILITIES REPORT 12/2/96

BUILT: 1932  
SQUARE FOOTAGE: 3,315

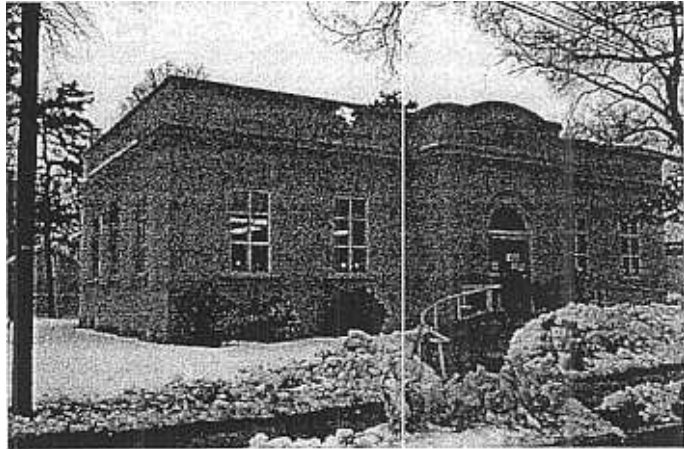
FIG. 1

- RAMPS:** ADA 4.8 Two 30' 0"± curved ramps extend from the main entrance to the public sidewalk. Curved ramps are not an acceptable means of handicap access by the code, however, a variance may be granted by the Architectural Access Board if all other conditions are brought up to code. New hand and guardrails are required on both sides of the ramps. See figure 1.

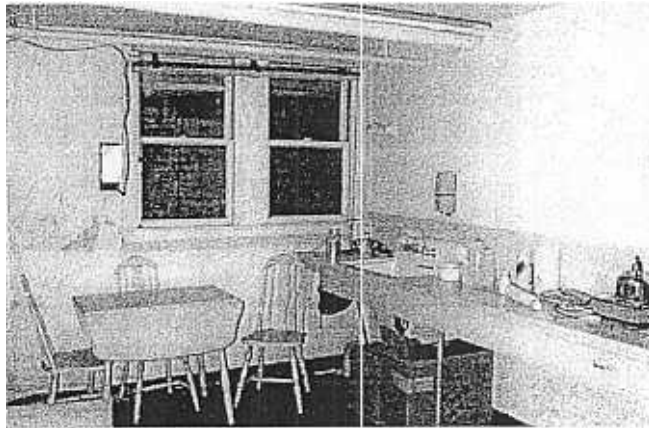
**KITCHEN:** MASS 45.1 The existing kitchenette facilities in the basement are completely inaccessible. See fig 3.

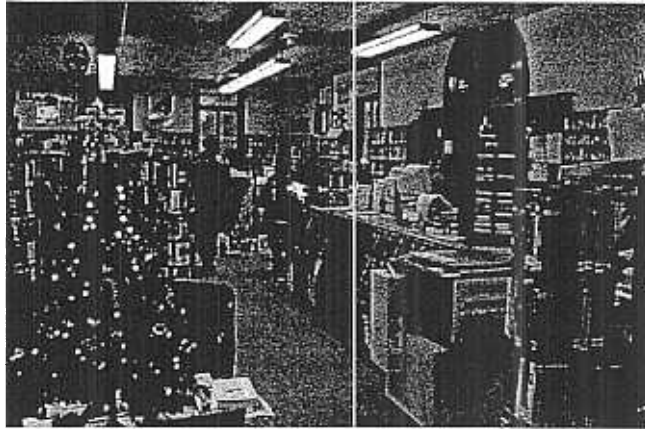
Fig 4

**COUNTER:** ADA 4.32.4 The existing check-out counter does not provide a 30" high x 36" wide accessible area. See figure 4.

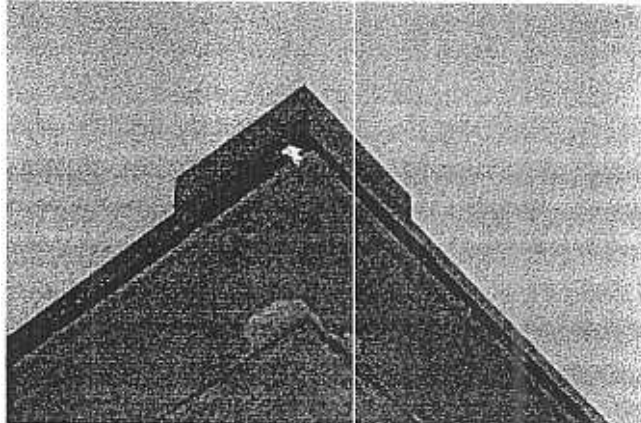
FIG. 5

**TRIM:** The fascia boards on the building have been replaced with plywood covered by metal trim. This metal trim does not extend down to cover the underside of the new plywood. This allows water to run along exposed wood and possibly behind the stucco finish. See figure 5.
