FOREST PARK BRANCH LIBRARY

380 Belmont Ave.
Springfield, MA 01108

FACILITIES REPORT 12/2/96

**CAOLO & BIENIEK
ASSOCIATES, INC.**
435 Cottage Street
Springfield, MA 01104

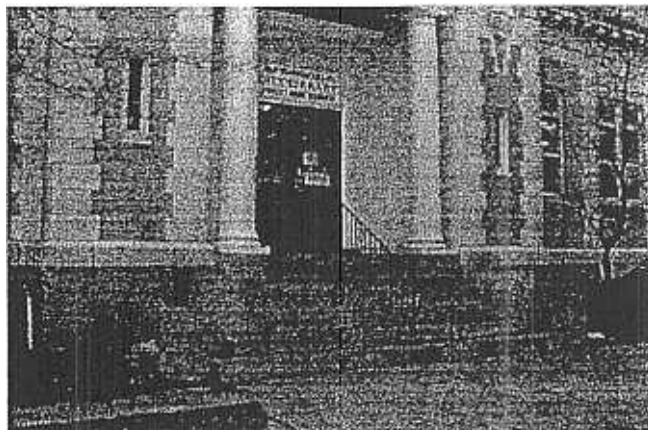
FIG. 2

RAMPS: ADA 4.8 A ramp at the front or side of the building is required for access into the first floor public library space. The ramp will be approximately 65' long with handrails and guardrails. See figure 2. If areas in the basement are to remain as public spaces, (toilet rooms, community room) then

- DOORS:** ADA 4.13.7 The front & side vestibule does not provide the minimum 48" of clearance between the doors. See figure 2. The side vestibule consists two pairs of 2' 6" doors. A 36" clear opening is required.
 ADA 4.13.10 The front and side exterior doors require new door closers/openers to meet the 5 pound push/pull force requirements.
 ADA 4.13.9 All doors in the building require accessible hardware including handles, levers, closers and locks.
 ADA 4.13.5 Several doors to private offices, toilet rooms and work rooms require new 36" clear doors.

- SEATING:** ADA 4.32 Existing movable furniture does not provide the required 27" high knee space under the tables. Computer tables are not the proper height and do not provide the required 27" knee space, however, these tables are adjustable. A minimum of 5% of all seating and tables are required to be accessible. See figure 2.

a lift or elevator would provide access from the exterior to the basement and first floor. An additional ramp is needed from the basement lobby (at bottom of stairs) into the community room. This ramp would be approximately 16'-0" long with handrails and guardrails.

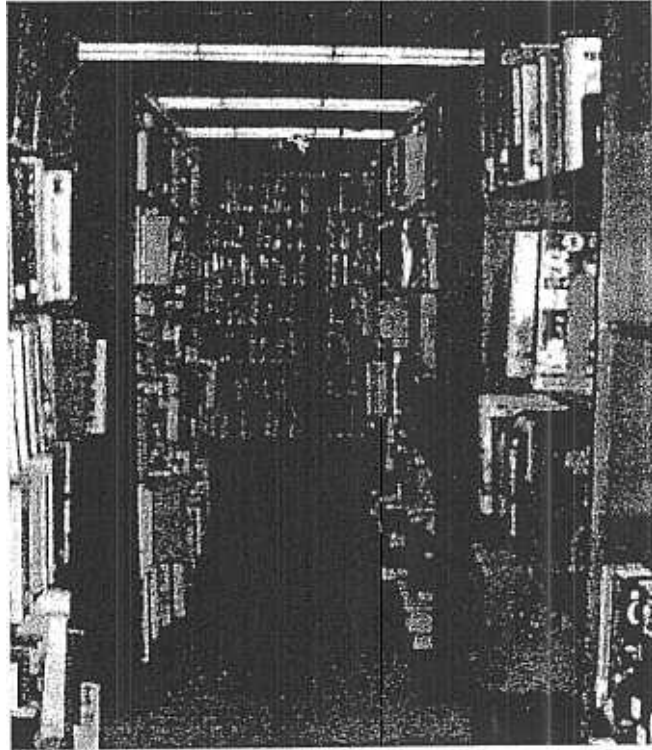
Fig. 3

STACKS: ADA 8.5 The existing stacks have the required 36" minimum between them in most areas, however, the books in the stacks project into the isles allowing only 30" of clear space which is inaccessible. The wood shelving at this library is not as deep as other branch libraries causing this problem. All of the stacks should be relocated to provide the required clearance between stacks. Some of the open space that exists in the children's section of the library that could be used in relocating the stacks. The side isle along the exterior walls are only 30" wide. Some of the existing stacks have a continuous removable step that should be removed at all locations to provide the proper clearances and better access to all shelving. See figure 3 and figure 4.

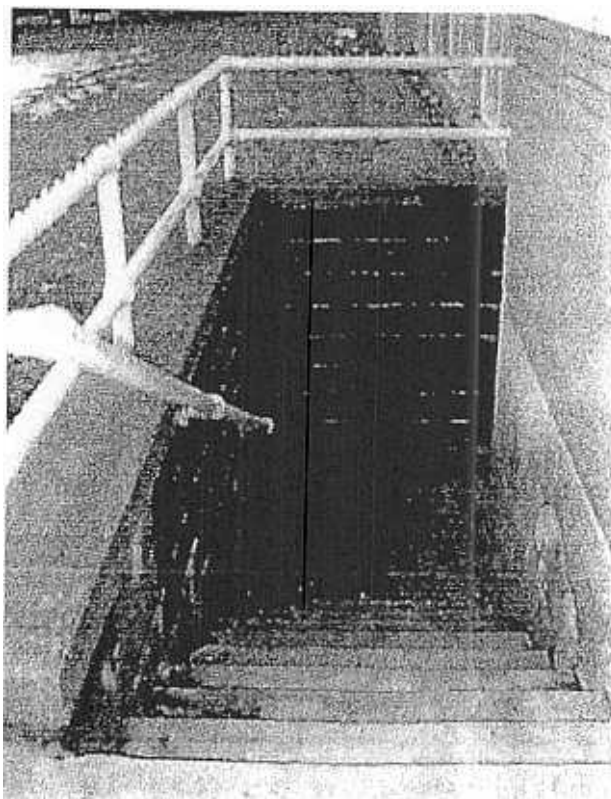
Fig. 5

GUARS The side egress stair from the Community Room is constructed as an open "well" concrete stair with pipe railings. These railings do not comply with the code. New guardrails are required the are 42" high with less than 6" space between all railings. See figure 5.

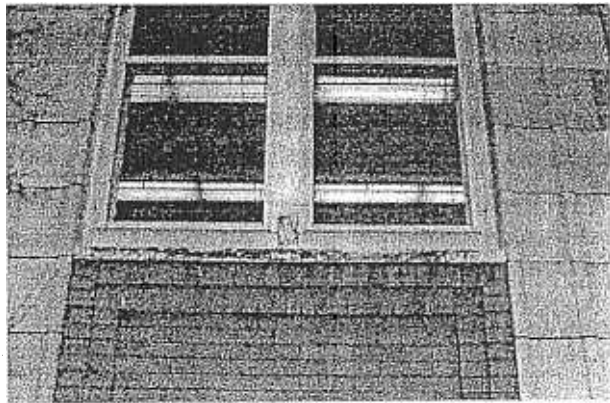
Fig. 6

WINDOWS: The existing windows are wood framed single pane glazing with aluminum storm windows on the exterior of some windows. The wood frames and sills of all of the windows show large amounts of deterioration and should be replaced. See figure 6. Four residential size air conditioners have been installed in four of

the large double hung windows on the sides of the building. The air conditioners have been installed with plywood to seal the remaining area. This installation is not air tight and does not allow the storm windows to be installed during the heating season.

Some of the smaller basement windows have also been sealed with plywood from the interior in the storage and mechanical rooms. All of these windows should be replaced.
