# INDIAN ORCHARD BRANCH LIBRARY

44 Oak Street  
Springfield, MA 01151

## FACILITIES REPORT 12/2/96

BUILT: 1909  
SQUARE FOOTAGE: 5,206±

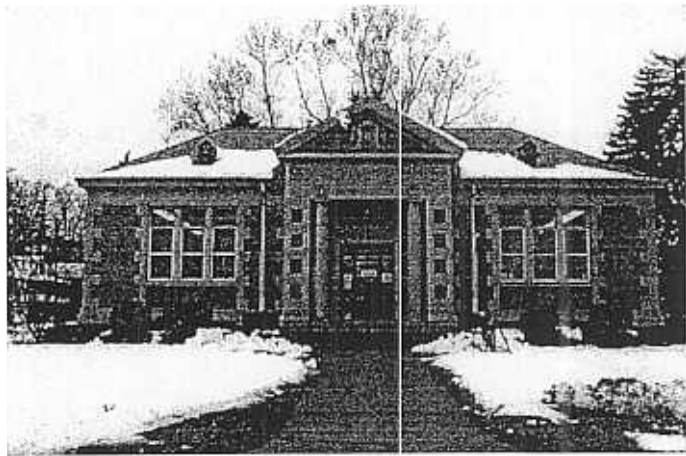
FIG. 1

**RAMPS:** ADA 4.8 A ramp at the front of the building is required for access. An existing set of steps on the exterior consists of 5 risers with a second set of steps inside the vestibule consisting of two steps. A 48'-0" long ramp would be required with handrails and guardrails to reach the finish floor elevation. The exterior book drop is located at the top of the exterior steps. See figure 1.

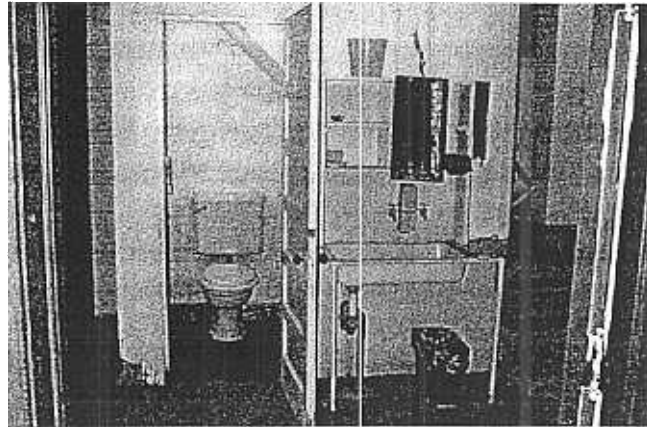
Fig 2

**STAIRS:** ADA 4.9 The second means of egress on the back of the building requires new handrails and a top landing at the exit door. Handrail are needed on the front steps on the exterior and in the entry vestibule. See figure 2.  
ADA 4.3.1 A 36" wide minimum sidewalk is required from the second means of egress door to safe location away from the building.  
ADA 13.5 The egress door to the exterior is only 28" wide and is required to be 36" wide.

A second inaccessible toilet room is located directly off of the private office. This 4'-0" x 5'-0" room consists of a toilet and sink. See figure 2.

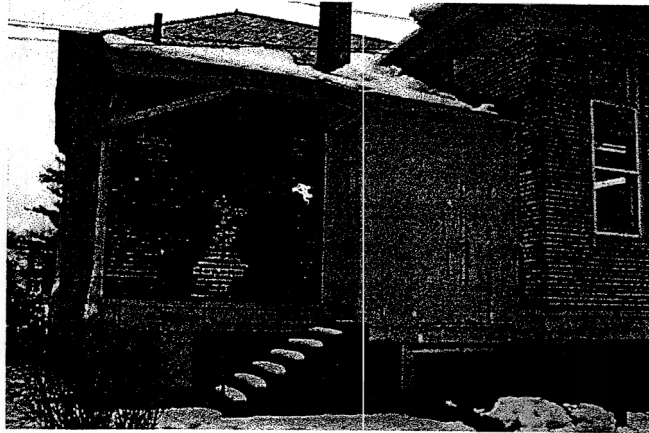
FIG. 3

**STAIRS:** All interior and exterior stairs to the building do not comply with the handrail requirements. All staircases and steps are required to have handrails and guardrails on both sides of the stairs that extend 12" beyond the top riser and 12" + one tread at the bottom riser. All handrails should be 1-1/4" to 1-1/2" in diameter and have 1-1/2" clear space between the wall. The staircase leading to the basement only provides 5' 6" of head clearance and not the 6' 8" minimum clearance required by code. See fig. 3.

**MASONRY:** The exterior masonry requires repointing in areas around the entire building. Large amount of repairs are needed near the rear means of egress of the building. See figure 3.
