# LIBERTY STREET BRANCH LIBRARY

773 Liberty Street  
Springfield, MA 01104

## FACILITIES REPORT 12/2/96

BUILT: 1931  
SQUARE FOOTAGE: 5,066

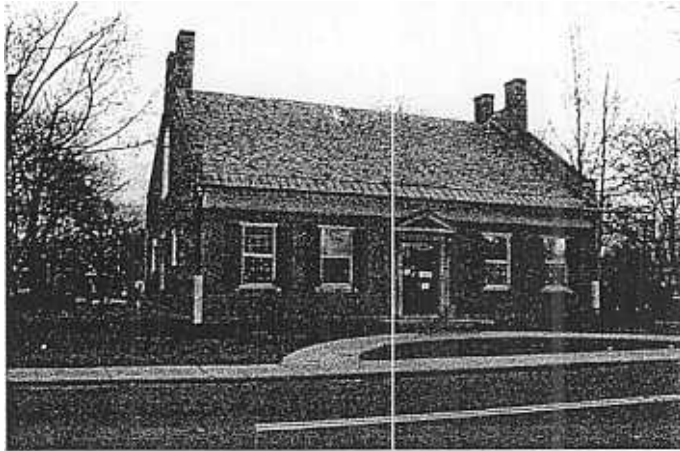
FIG. 1

- RAMPS:** ADA 4.8 A ramp at the front of the building is required for access. The ramp will be approximately 26' long with handrails and guardrails. The existing center guardrail on the entry steps does not comply with the code. See figure 1.

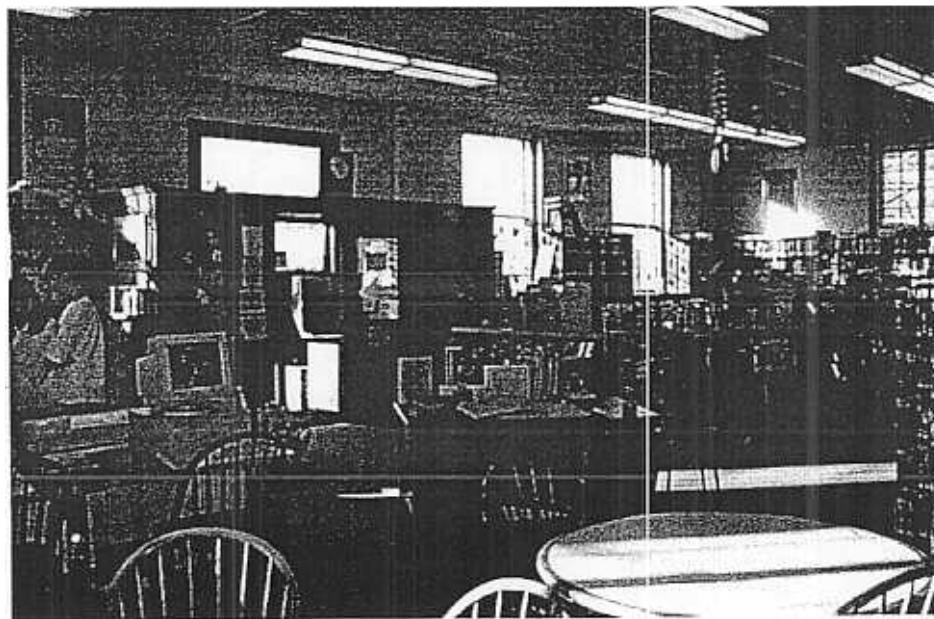
FIG. 2

- DOORS:** ADA 4.13.7 The front vestibule does not provide the minimum 48" of clearance between the doors. See figure 2.  
ADA 4.13.10 The front and rear exterior doors require new door closers/openers to meet the 5 pound push/pull force requirements.  
ADA 4.5.2 The front entrance door requires a new threshold.  
ADA 4.13.9 All doors in the building require accessible hardware including handles, levers, closers and locks.  
ADA 4.13.5 The door into the first floor private office is not the required 36" wide.

- SEATING:** ADA 4.32 Existing movable furniture does not provide the required 27" high knee space under the tables. Computer tables are not the proper height and do not provide the required 27" knee space, however, these tables are adjustable. A minimum of 5% of all seating and tables are required to be accessible. See figure 2.

- COUNTER:** ADA 4.32.4 The existing check-out counter does not provide a 30" high x 36" wide accessible area. See figure 2.
- STACKS:** ADA 8.5 The existing stacks have the required 36" minimum between them, however, the stacks are only 30" away from the wall mounted shelving which is inaccessible. The existing continuous removable step

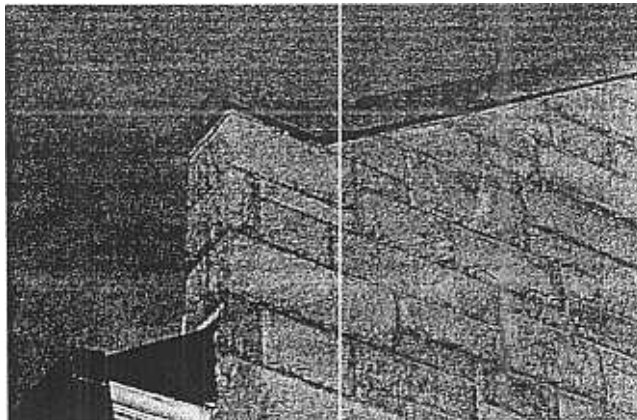
FIG. 3

**MASONRY:** The exterior masonry requires repointing at the parapet and base of the building. Large openings exist at the coping stones of the parapets. See figure 3.
