# MASON SQUARE BRANCH LIBRARY

765 State Street  
Springfield, MA 01109

## FACILITIES REPORT 12/2/96

BUILT: 1955  
SQUARE FOOTAGE: 17,141

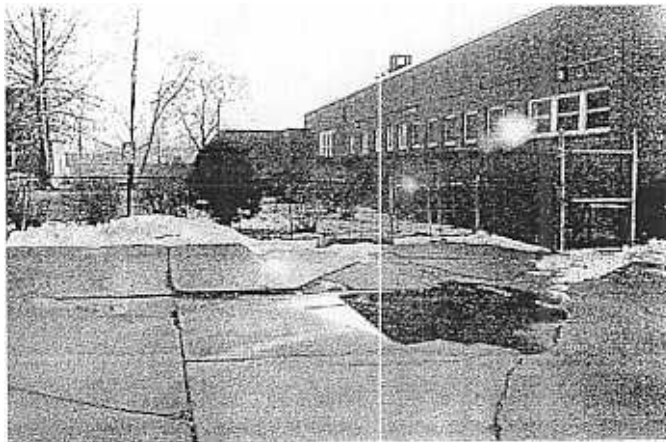
FIG. 2

**SITE:** ADA 4.1.2 One existing accessible parking space and isle needs to be indicated by striping in the front parking lot. The existing sign poles indicating the spaces in the front and rear parking lots need to be straightened. The concrete paving in the front parking lot is in very bad condition. Several cracks and unlevel surfaces make the paving inaccessible and should be replaced. See figure 2.

SITE:	Accessible parking:	\$10,000.00
RAMPS:	New ramps from side egresses:	\$5,000.00
DOORS:	Widen doorways:	\$5,000.00
	Hardware:	\$7,500.00
TOILETS:	Two accessible toilet rooms:	\$7,500.00
SIGNS:	New signage throughout building:	\$500.00
SEATING:	New accessible tables & chairs:	\$500.00
CONTROLS:	Relocate existing controls:	\$1,000.00
MATS:	New anchored mats:	\$500.00
STAIRS:	New accessible rails and nosings:	\$2,500.00
SINKS:	New accessible sink in workroom:	\$350.00
KITCHEN:	New Accessible fixtures in all kitchens:	\$5,500.00
CLOSETS:	Lower existing closets:	\$250.00
PHONE:	Lower existing public phone:	\$300.00
HAZARDS:	<u>Correct installation of display cases:</u>	<u>\$1,000.00</u>
	Total:	\$47,400.00

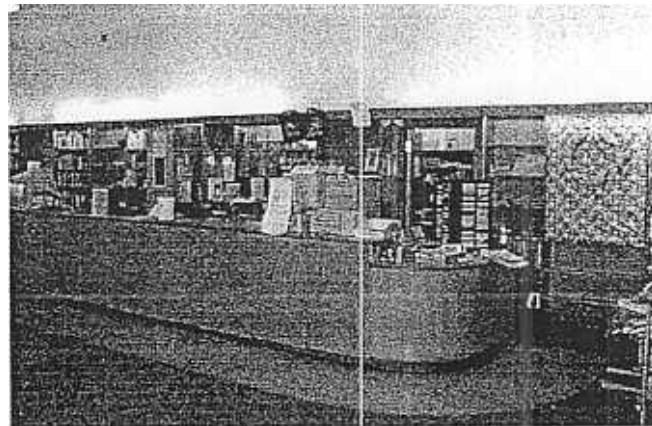
FIG. 3

**COUNTER:** ADA 4.32.4 The existing check-out counter is equipped with a 30" high x 40" wide accessible area that could be used by a handicap person, however, this area is being used as display and storage counter. This area should be cleared to provide accessibility to handicap occupants See figure 3.

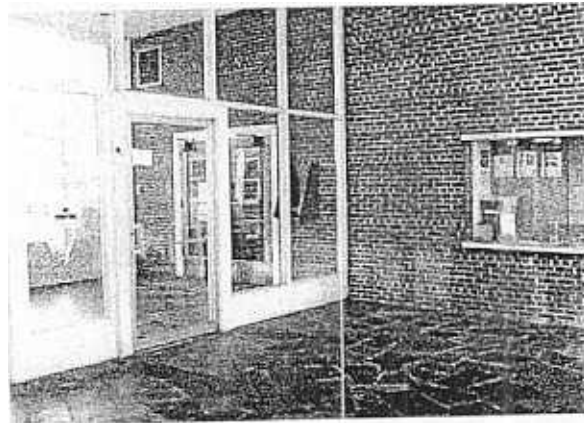
FIG. 4

**PHONE:** MASS 37.1 A wall mounted phone enclosure (the phone has been removed) is located in the vestibule that is too high. The highest operable point on the phone should be at 48" above the finish floor. See figure 4.

**HAZARDS:** MASS 37.4 The display cases located at the main entrance of the library project more than the maximum code allowance of 4" into the paved area of entry. Existing mechanical equipment in the basement of the building is located in the open floor space. If the basement is public space or to be used by a handicap employee, than this equipment would be required to be protected or shielded. See figure 4.

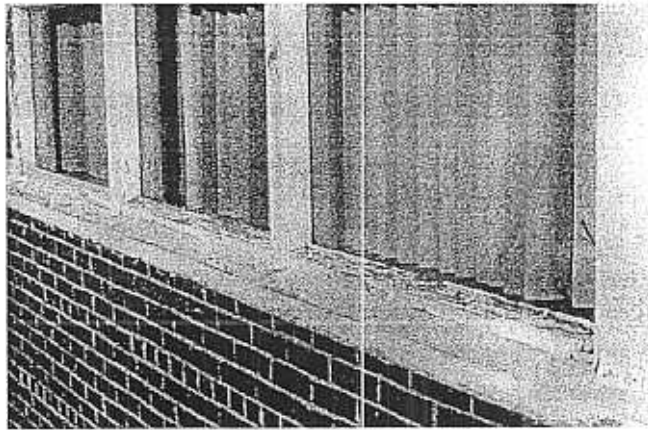
FIG. 5

**WINDOWS:** The existing windows are wood framed with single pane glazing. The exterior wood framing needs to be cleaned and painted on the entire building. Interior framing is damaged in the vestibule and should be replaced. All of the window frames need to be caulked at the window frame and masonry wall joints. See figure 5.

EXTERIOR:	Repaired & paint:	\$2,500.00
WINDOWS:	Clean, repaint & recaulked:	\$7,500.00
SIDEWALK:	Replace front sidewalk:	\$1,000.00
MASONRY:	Repair flagstone paving:	\$500.00
	Total:	\$11,500.00

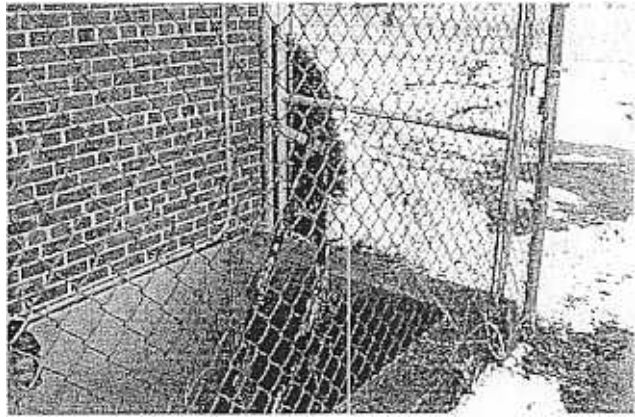
FIG. 6

**LADDER:** The ladder and egress well from the basement is not a legal means of egress in its present condition. The ladder is very steep and is rusted beyond safe usage. A fence and gate has been installed directly at the top of ladder at the well that is lock which does not allow occupants to move to a safe location away from the building.

This the ladder should be replaced and the fence and interior illuminated exist sign should be removed. See figure 6.

LADDER:	Replace ladder and well with accessible stairs:	\$10,000.00
EGRESS:	Provide a rated means of egress from the basement:	\$15,000.00
	Total:	\$25,000.00
