SIXTEEN ACRES BRANCH LIBRARY

FACILITIES REPORT

12/2/96

**CAOLO & BIENIEK
ASSOCIATES, INC.**
435 Cottage Street
Springfield, MA 01104

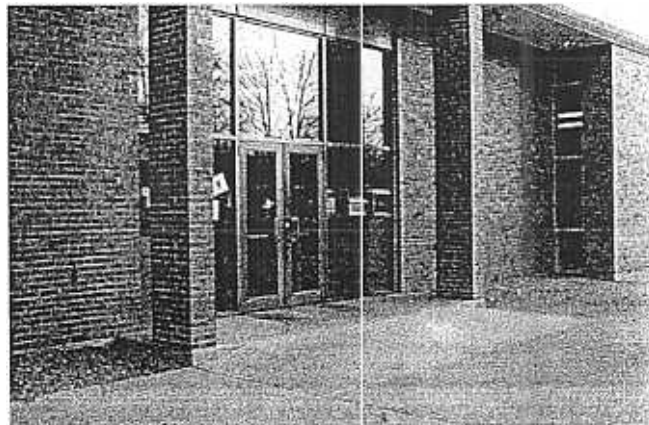
FIG. 2

RAMPS: ADA 4.8 The existing ramp at the front entrance is not accessible because it is too steep. A new 5' 0"± ramp is needed at the front entrance. The side egresses from building should also have 5' 0"± ramps from the landings to provide accessible means of egress. See figure 2.

DOORS: ADA 4.13.7 The interior and exterior vestibule doors consist of two 30" doors which do not provide a 36" clear opening. All doorways into toilet rooms, offices & work areas needed to be enlarged to 36". See figure 2.
ADA 4.13.10 The interior and exterior vestibule doors require new door closers/openers to meet the 5 pound push/pull force requirements.

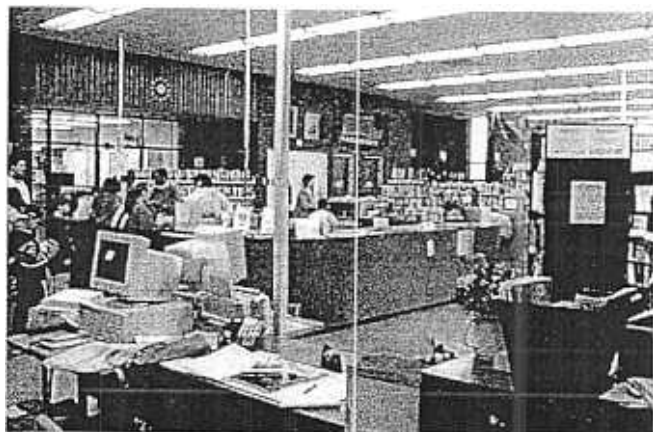
FIG. 3

CONTROLS: ADA 4.27 All controls, switches, dispensers, etc. are required to be no higher than 54" from the highest operable point to the floor. See figure 3. The following items do not comply:

- thermostat
- electrical panel
- fire extinguishers

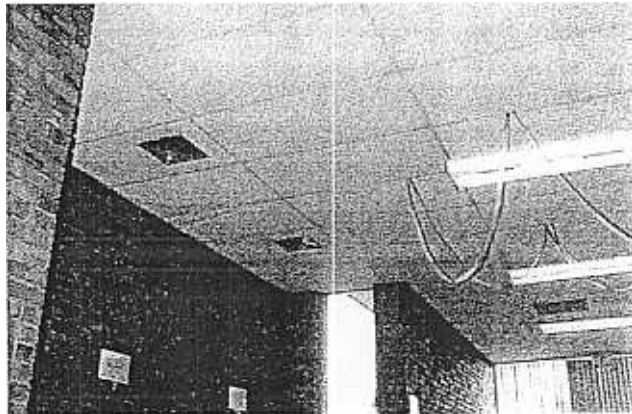
FIG. 4

LEAKS: Several ceiling tiles are stained due to leaks throughout the building. These leaks could be from the plumbing systems but are probably roof failures indicated by the amount and locations of the stains. The access hatch to roof was locked at the time of the survey. see figure 4.

LIGHTING: All of the light fixtures covers are missing throughout the building. Also two of the four fluorescent bulbs have been removed from all of the light fixtures in the entire building. The fixture covers should be reinstalled to eliminate the lighting "bright spots" and provide a more consistent foot candle level throughout the library. See figure 4.

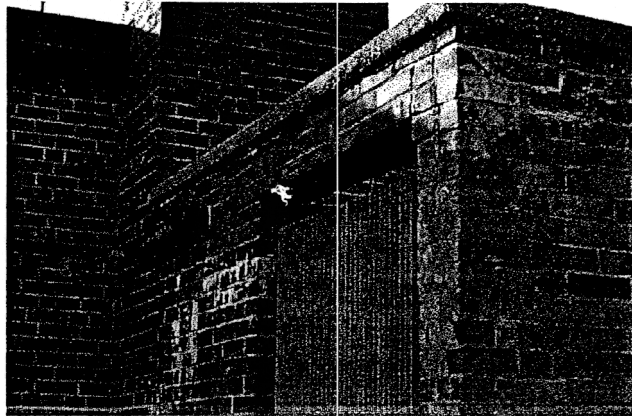
FIG. 5

MASONRY: The interior & exterior masonry on the building is in good condition. A small amount of repointing is needed at the HVAC fan unit enclosures at the rear of the building. See figure 5.
